PHASE I ENVIRONMENTAL SITE ASSESSMENT

Two (2) Parking Lot Properties
SEC of Everett Avenue and Rockefeller Avenue
Everett, Washington

YMCA OF SNOHOMISH COUNTY

May 18, 2006

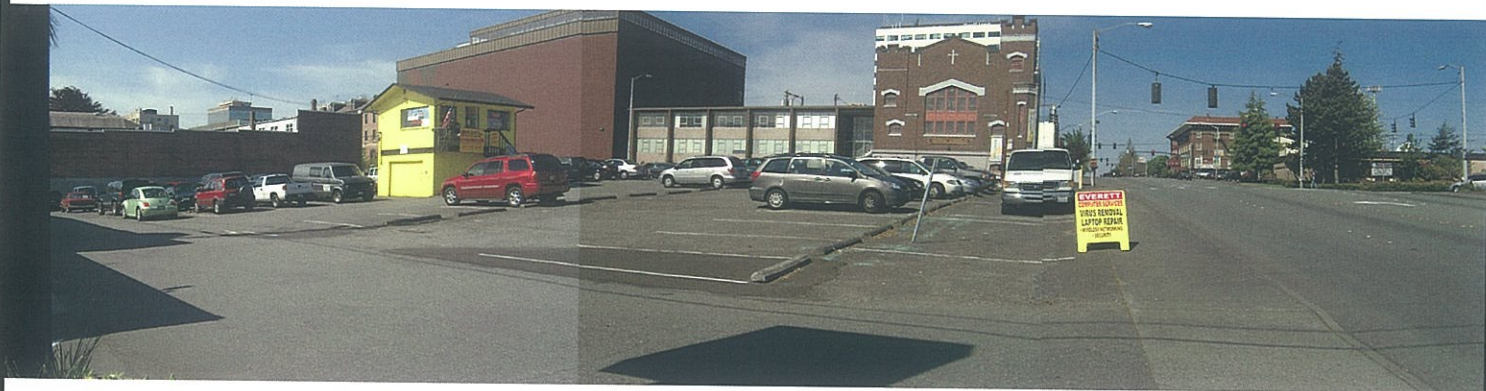
Photo 1: Subject property as viewed from the northeast corner of site, near adjacent bank property. YMCA and Lutheran Church are visible in background of photo.

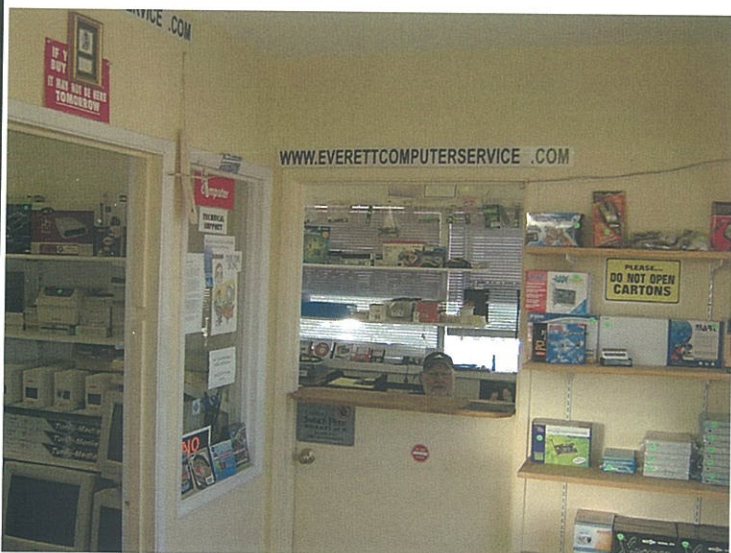
Photo 2: Interior of computer repair business on property.

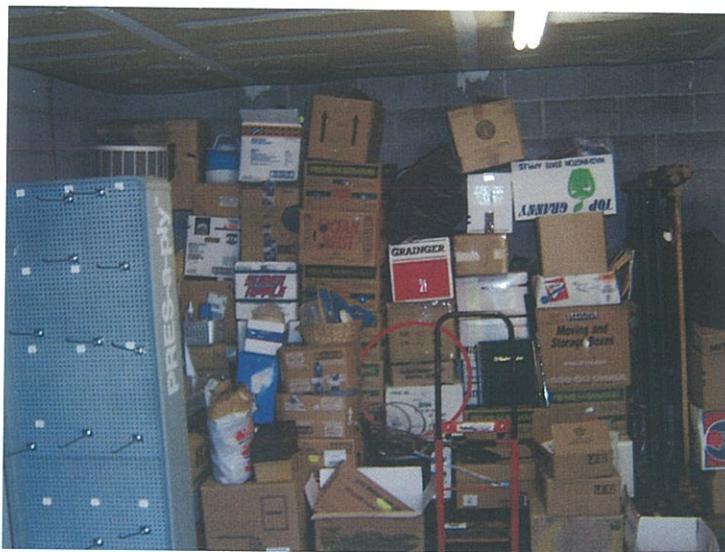
- The bottom floor of this building is an asphalt paved area used predominantly for storage of either "garage sale" items or computer monitors and other similar parts awaiting disposal. Some staining was noted on the asphalt surface.

Photo 3: Example of items stored within "basement" of building.
