Building Asbestos & Lead Paint Demolition Survey

**Former Belladonna / Krunch Skate
411 E. Sprague Avenue & 12 N. Grant Street
Spokane, WA 99202**

Project Name: University District - Asbestos & Lead Paint Demo Survey
 Site Address: 411 E. Sprague Ave., Spokane, WA 99202

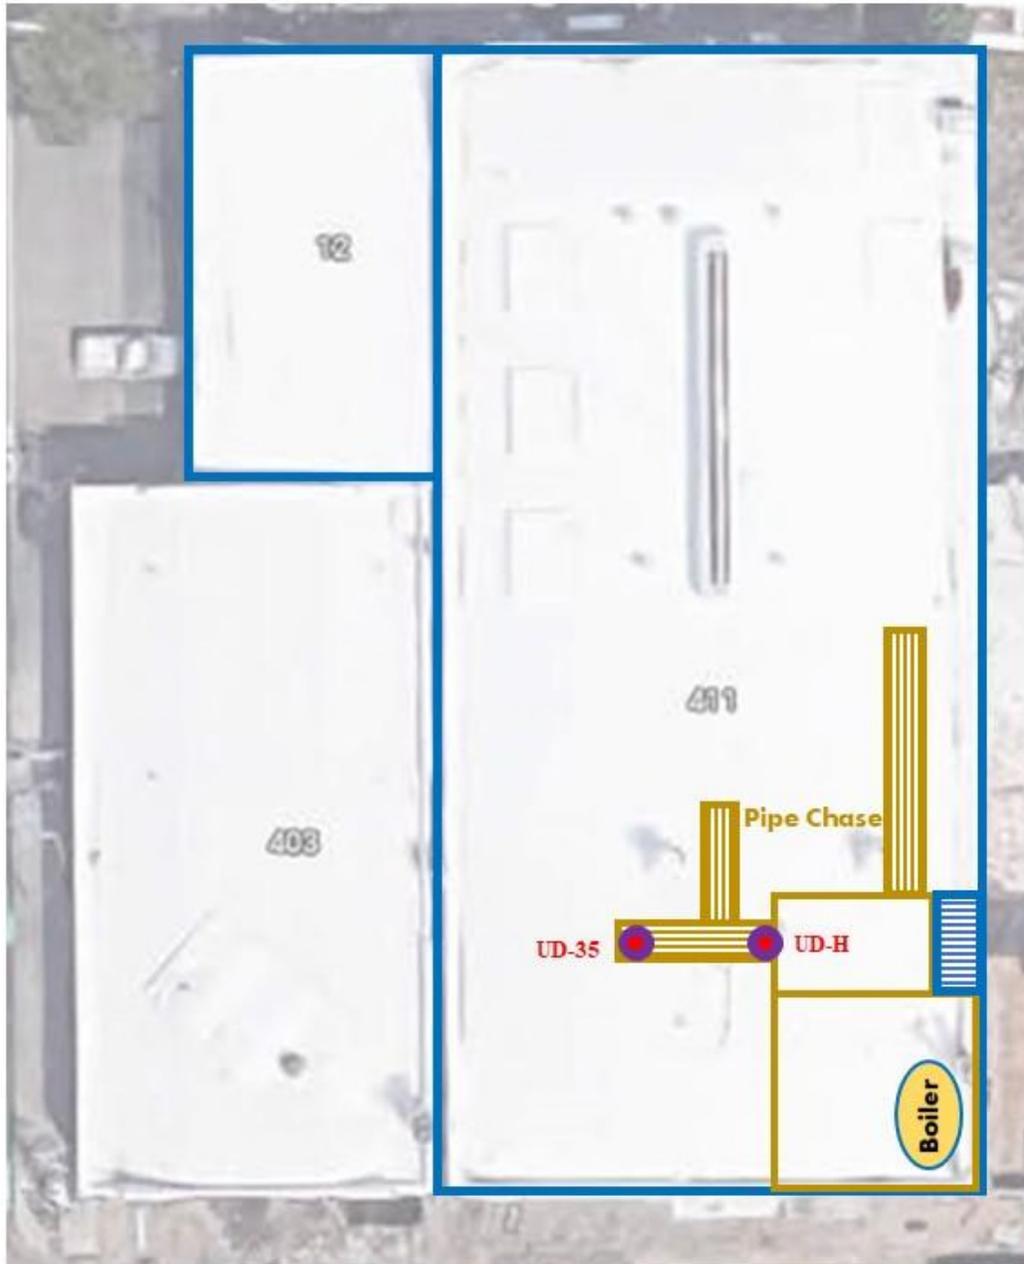
Boiler Room and Steam Pipe Chase
Suspect ACM Sample Locations,
PRISM Environmental Asbestos Survey, 11/17/2021

Boiler room in basement and associated steam pipes contain remnants of asbestos pipe lagging on corners and connections. Asbestos cloth pipe lagging observed in the pipe chase in floor. Asbestos pipe lagging insulation observed in mezzanine on steam pipes. Multiple layers of roofing and black tar on the roof.
