PHASE I ENVIRONMENTAL SITE ASSESSMENT

Everett Family YMCA
2720 Rockefeller Avenue
Everett, Washington 98201

March 4, 2004

JN 4157-1

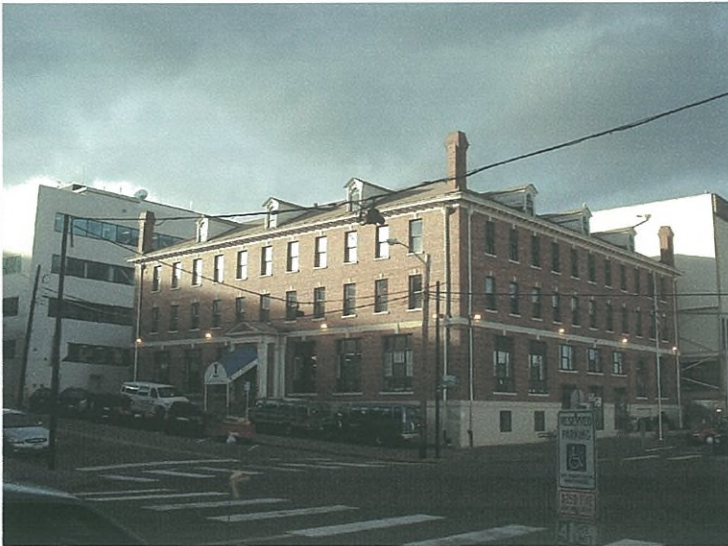
View of subject property looking northwest.

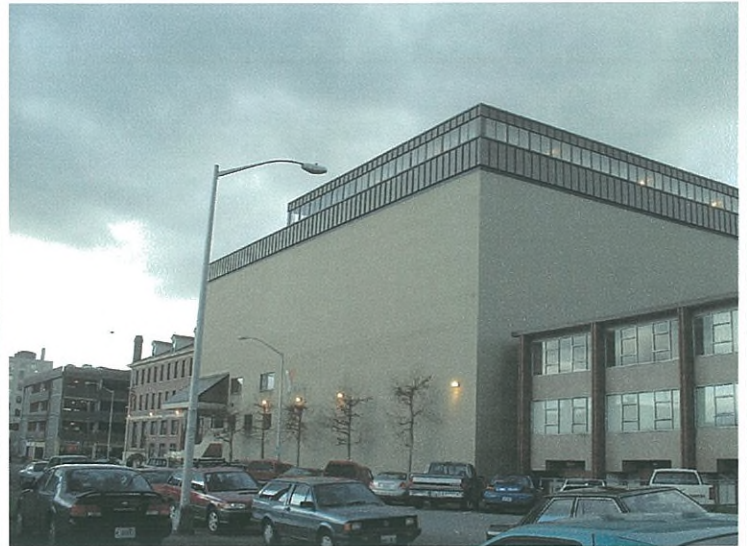
View of subject property looking southwest

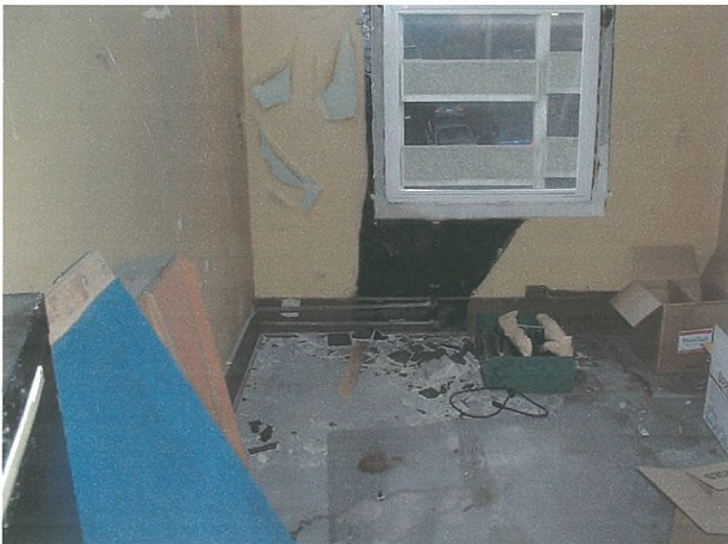
- Interior walls throughout the building are painted plaster or concrete. The third and fourth floors of the 1921 building are unoccupied and are informally named "ghost town" by YMCA staff. Significant damage, reportedly resulting from the 2001 Nisqually earthquake, was noted on all of the plaster walls and ceilings on the third and fourth floors.

As noted earlier in this report, the plaster wall and ceiling material throughout the 1921 building is suspected to contain asbestos and is significantly damaged on the third and fourth floors (noted as "ghost town"). Access to the third and fourth floors of the 1921-vintage section of building should be completely restricted until such time that either adequate sampling and testing (i.e. at least seven (7) samples) demonstrating non-asbestos content is performed or the material is either removed or encapsulated. Borrowing evaluation criteria adopted under the Asbestos Health Emergency Response Act (AHERA, 40 CFR Part 763), the other "suspect" and confirmed asbestos containing materials enumerated earlier are in "good" condition. In the current use and condition, these other materials pose no threat to public health or to the environment.

Damaged Plaster in a Sleeping Room

To reduce exposure to potential future liability, and in an effort to comply with regulations regarding the presence of asbestos in commercial buildings under Chapter 296-62-07753 WAC, it may be prudent to consider implementation of a management policy (Operations and Maintenance Program/O&M) whereby all maintenance, repair, or service personnel who may be engaged to work on the property are formally advised (i.e., signed acknowledgment) as to the presence of asbestos-containing materials (ACM) prior to commencement of any work associated with the ACM.

As it is our understanding that the owner intends to renovate portions of the structure containing asbestos, please note that applicable sections of WAC 296-65 require that all projects relating to construction, demolition, repair, or maintenance where release or likely release of asbestos fibers into the air could occur must be performed by "certified asbestos workers". Additional information may be obtained through the offices of Environmental Associates, Inc., or directly from the Washington State Department of Labor and Industries, P.O. Box 207, Olympia, Washington 98504. Finally, if future representative sampling and laboratory testing of these "suspect" plaster and sheet vinyl materials were to confirm that they do not contain asbestos, these recommendations may then logically be disregarded for those materials.

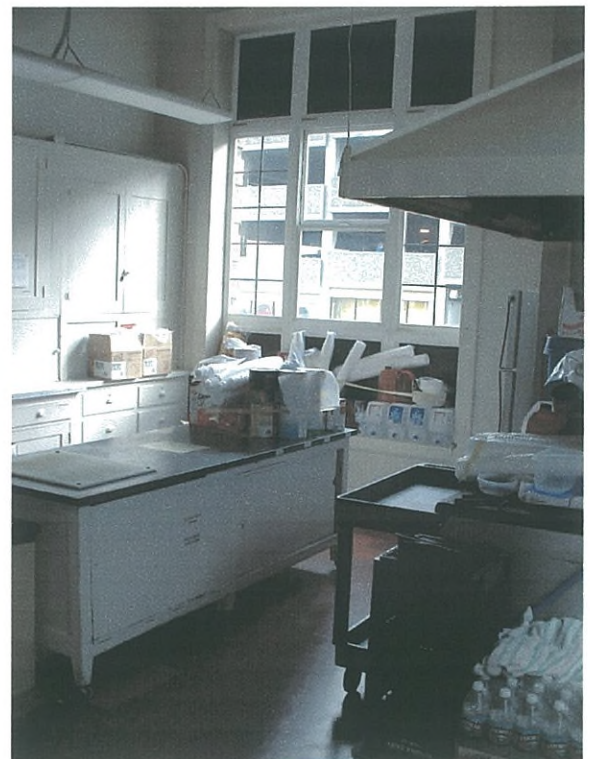
Old Kitchen
