Asbestos Northwest, LLC - Survey Report

Survey Location: 2765 Rockefeller Ave Everett WA

Prepared for: Ascendent Demolition

Date: July 16th – 20th, 2020

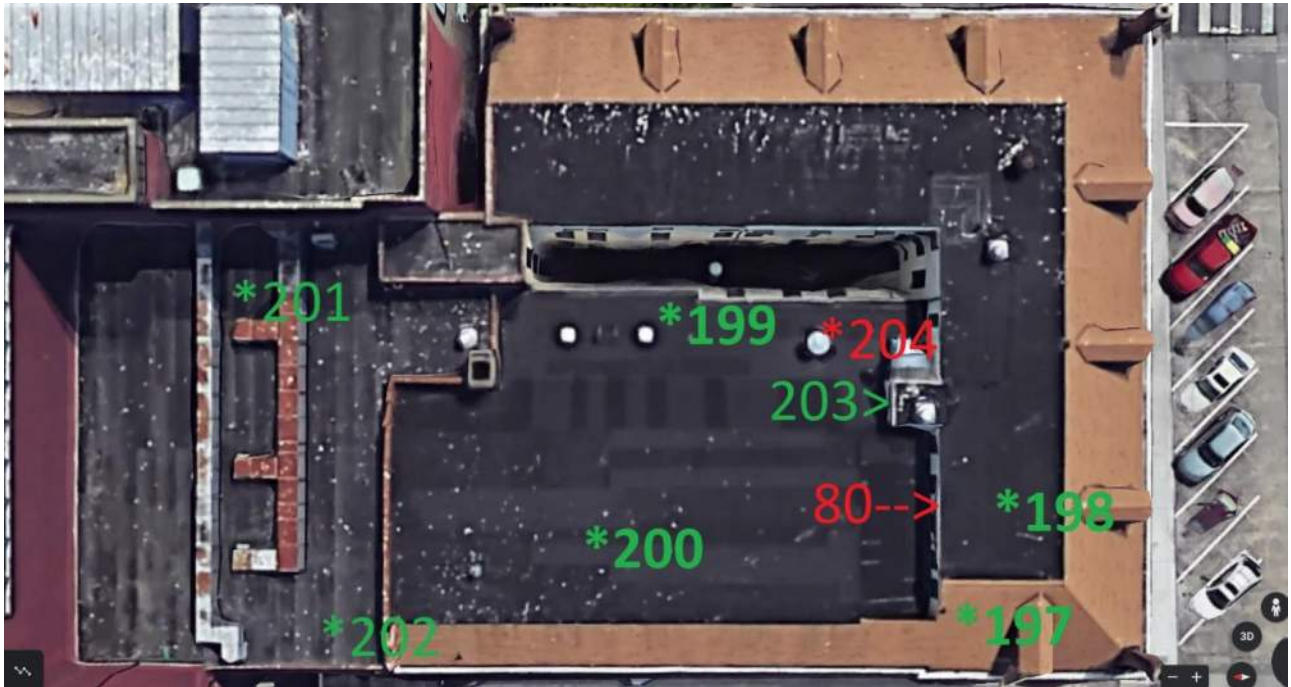
Roof

Most roofing samples were asbestos free. **However an asbestos containing tar paper product was in place on the roof sampled from behind the gutters at the rear of the 5th floor dormitories.** This material was not found elsewhere on the roof. **An asphaltic sealant on a ventilation duct in the same area contained asbestos.** This material was not seen elsewhere on the roof.

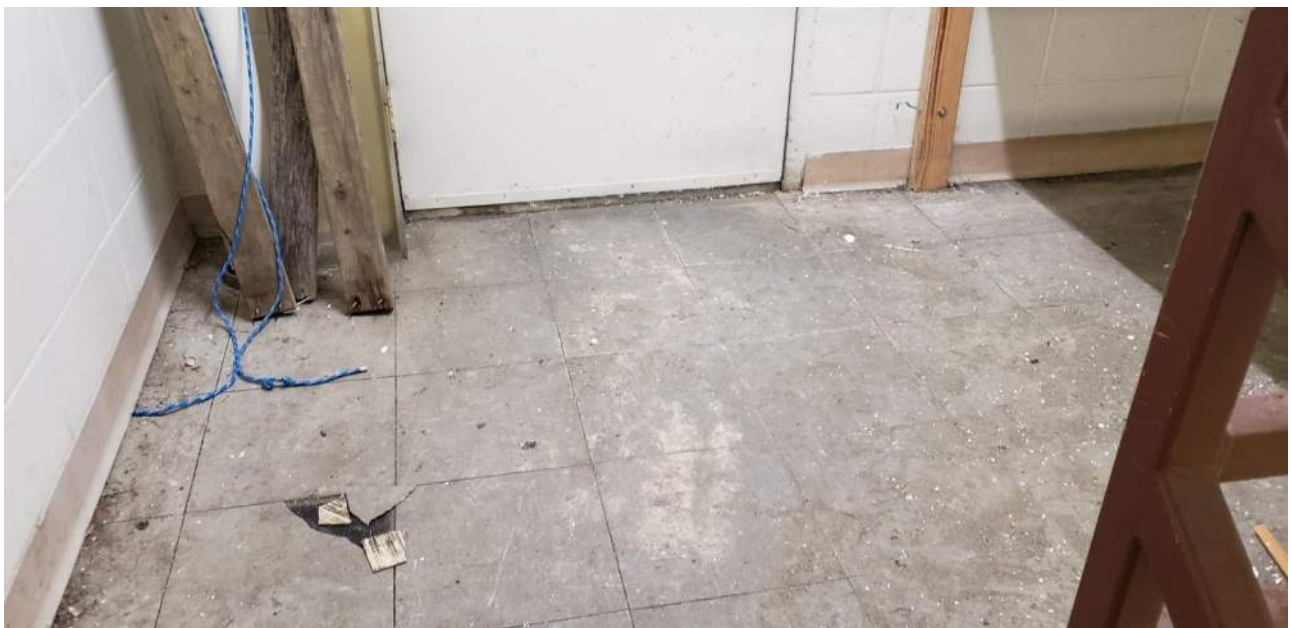
Sample 6 Location

Description and Asbestos Type	Material Type and Estimated Quantity	Locations
Black Mastic	Non-Friable Miscellaneous Material See Conclusions	6- Rooftop SW Stair Landing Floor.
Vinyl Tile and Black Mastic 3-5% Chrysotile Asbestos	Non-Friable Miscellaneous Material See Conclusions	40- Store Room Floor 82- 5th Floor NE Room Floor 107- 4th Floor SW Room Floor 183- Basement Fitness NE Area Floor 44- Hall by Locker Room Entrance 81- 5th Floor Hall Floor 109- 4th Floor East Hall Floor 56- NW Maintenance Office Floor 83- 5th Floor NE Room Floor 108- 4th Floor South Mid Room 164- 2nd Floor Stage 169- 2nd Floor North Classroom 148- 3rd Floor East North Office Floor 175- 2nd Floor Small Center Office Floor 181- Basement Lobby Floor 149- 3rd Floor North Office Floor 150- 3rd Floor Bathroom Floor 187- Basement Fitness North Hall Floor
Brittle Underlayment 3% Chrysotile Asbestos	Non-Friable Miscellaneous Material See Conclusions	151- 2 nd Floor SE Room Floor

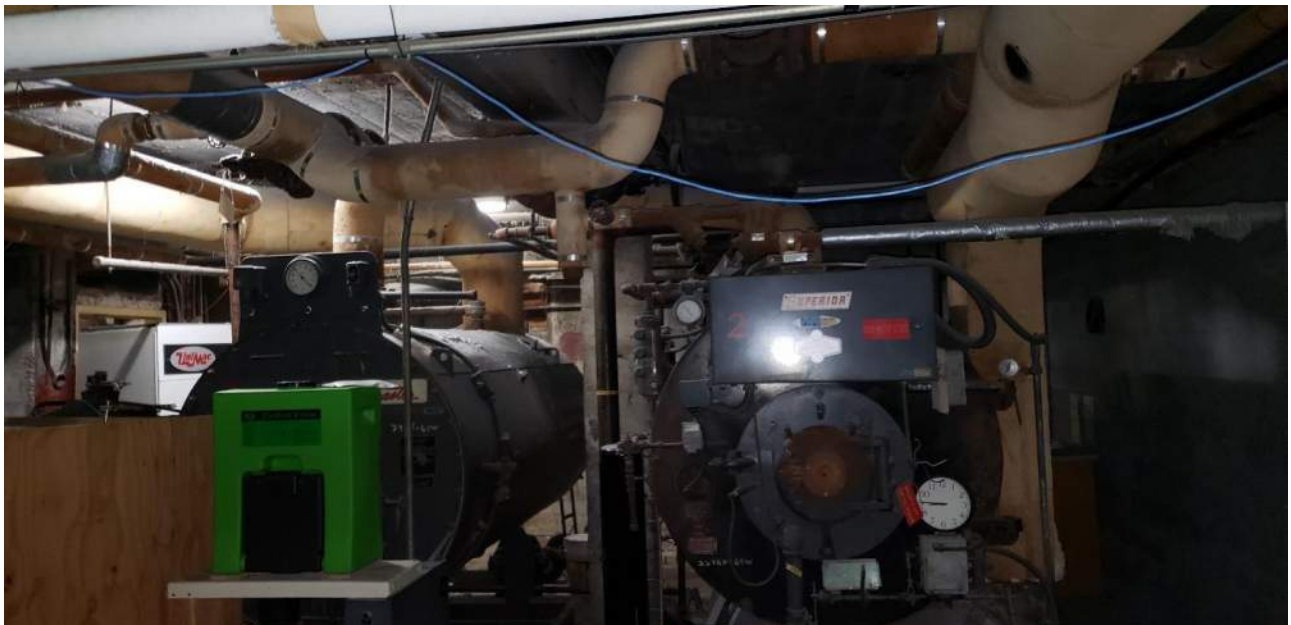
1920's Boiler Room

A large quantity of asbestos containing TSI were found in this portion of the building. This included gaskets, elbows, corrugated wrap and paper on both the boilers and ducting in the mechanical room. This material was in damaged condition and had been disturbed in

a number of locations. These materials were also found on pipework in the rest of the basement area and on the 4th and 5th floor of the building and likely elsewhere in the building. **The total quantity of these materials is unknown but they are extensive.**

Any identified asbestos containing material must be abated before demolition can continue. A Certified Asbestos Abatement Contractor must carry out abatement.
